**CONSERVATION AREA
CHARACTER APPRAISAL**

AMINGTON HALL

**TAMWORTH BOROUGH
COUNCIL**

Date: March 2008

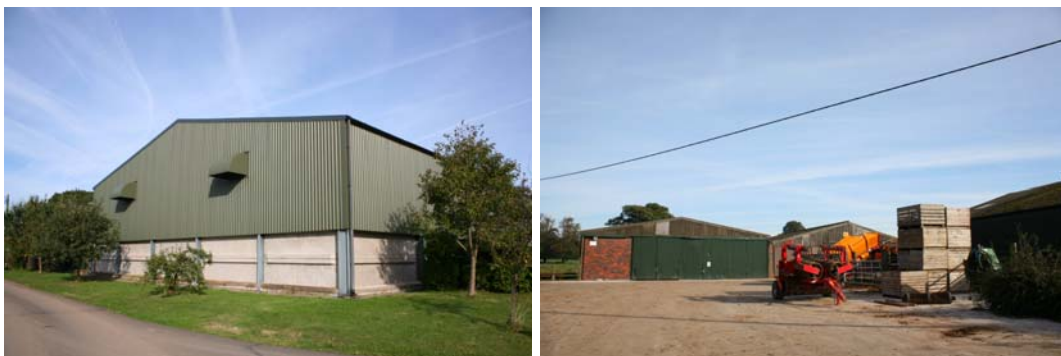
- 5.1.1 The area around the Old Hall has the feeling of a working farm. It is accessed off the main sweeping driveway (with two cattle grids) which runs through the fields and parkland from the Ashby Road. Views across the estate from the west are dominated by the modern large brick and steel-framed farm buildings with asbestos and tin roof coverings. The presence of stock fencing, tubular steel gates and farm machinery strengthen the agricultural character of the site. The Old Hall, an interesting house which has evolved architecturally over the centuries, still retains much of its identity and is separated from the other developments in the farmyard by its own front and back gardens.

The working farm maintains the area's agricultural character

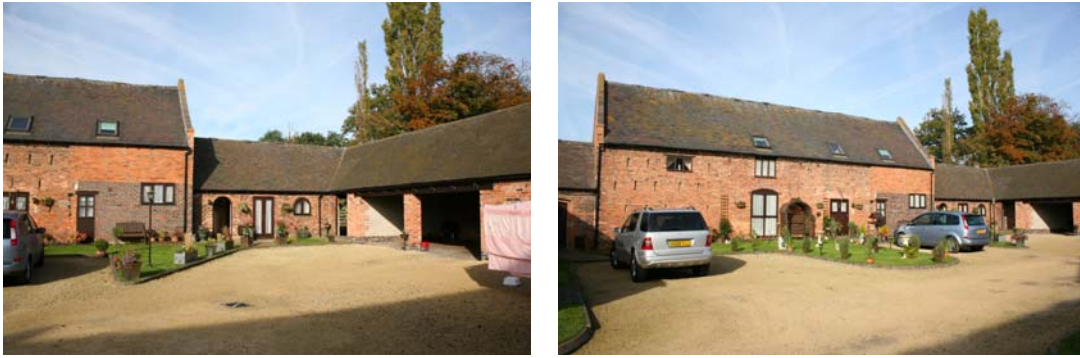
- 5.1.2 The courtyard of former outbuildings southwest of the Old Hall has been converted into modern residential use. The buildings have retained their features and the courtyard space is still easily recognisable. Nevertheless the modern dark-stained window frames, insertion of French windows, well-kept green lawns, stone effect urns, Victorian style outdoor lights, dwarf conifers, gravel driveways and obligatory car ports have somewhat undermined the courtyard's original character. In this sense the conversion lacks some integrity.

The converted farm buildings

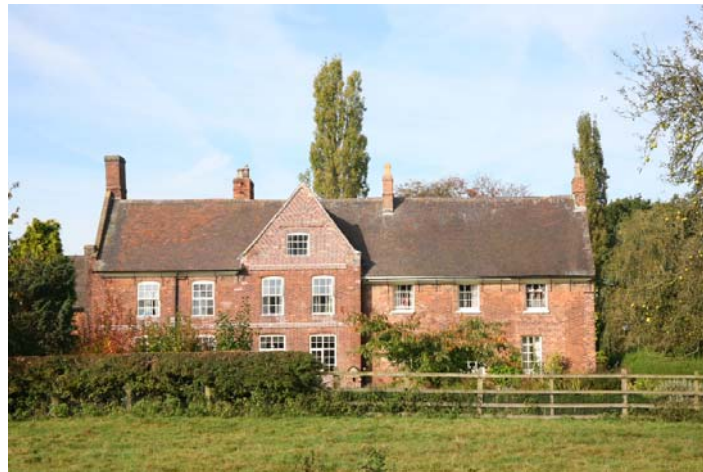
- 5.1.4 The Grade II listed Old Hall formed the original focus of this historic estate. It was built in the 16th century as a timber-framed, baffle entry house. It has undergone many alterations; the majority of the walls are of 18th-century brickwork, the thick southeast wall having two 18th-century windows. The entrance in the projecting northwest wing has a more ancient nail-studded door. The narrow extension northeastwards has modern windows but, from the traces of blocked openings in the walls, appears to have been a former outbuilding now converted to residential purposes. The Old Hall is clearly at the heart of this area of the estate, and its various additions and alterations add to the understanding of the history and development of the estate and the fortunes of its owners.

Amington Old Hall

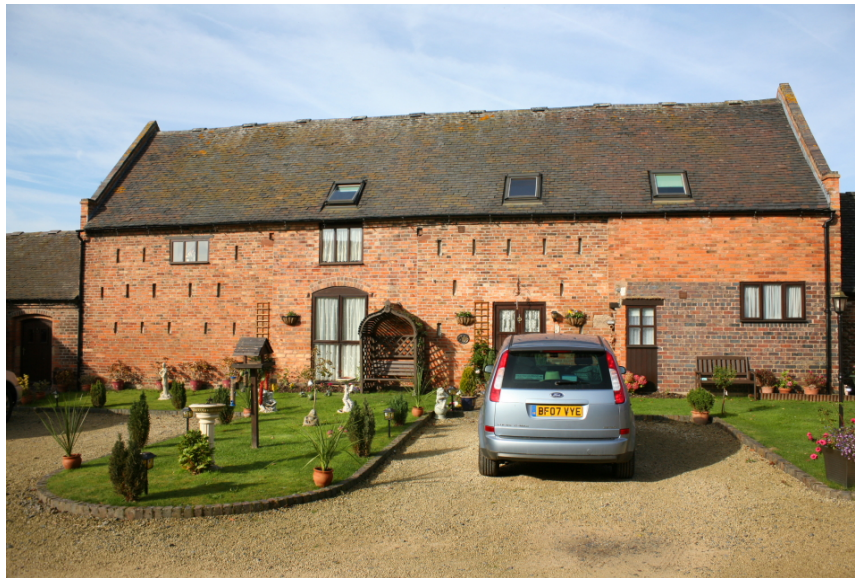
- 5.1.6 The modern farm buildings to the west of the Old Hall are not aesthetically attractive but represent the need for modernisation in agriculture and maintain the integrity of the working farm. The conversion of the farm's older outbuildings is a sign of the necessary diversification faced by many farms in order to increase income.
- 5.1.7 The dark-stained window frames of all of the buildings are an unattractive feature. The small low range which forms the southern side of the courtyard has a rendered southern elevation which together with its dark window frames and French windows creates a particularly unsympathetic ensemble. The small manicured gardens in front of the properties with ornamental statuary have the character of a suburban residential area not a rural estate.

The well maintained gardens are unfortunately out of character with the historic farmstead

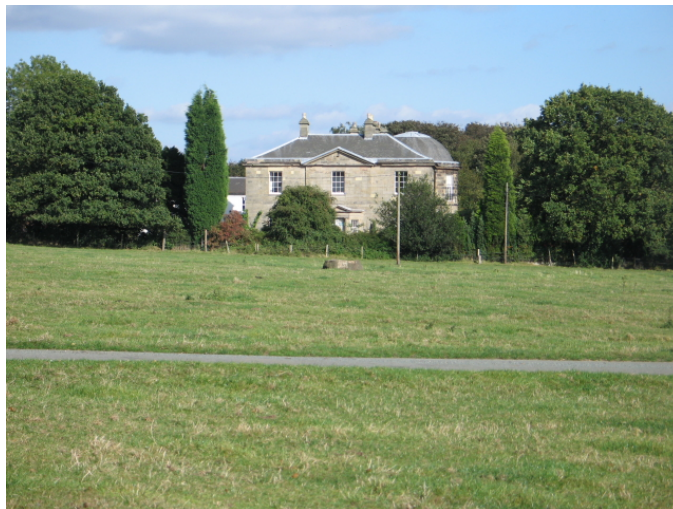
5.2.1 Amington Hall was built in c.1810 as the Repington family home. This grand classical style house, surrounded by trees, stands in its own distinct area within the larger conservation area. The long tree-lined drive from the lodge on Ashby Road down to the house, taking in views of the landscaped parkland to the front of the house, is an important element of the estate. Surprisingly, however, on approaching the house the viewer is first struck not just by the Grade II* listed house but by two rather incongruous bungalows complete with tarmac driveways, front lawns and conifers. Fortunately the house itself is some distance away but even so it does not stand in splendid isolation. A painted brick rear range, now four homes and reminiscent of a row of terraced cottages sits somewhat uncomfortably behind the grand formal façade of the Hall but has visual interest.

View to the house from the parkland

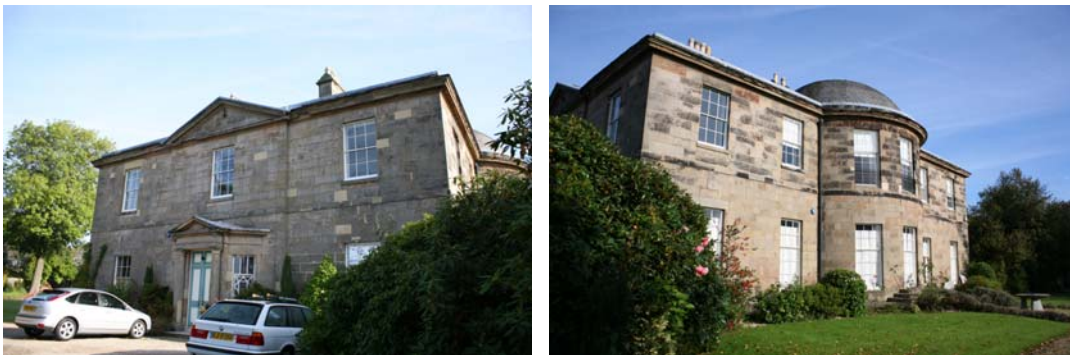
5.2.3 The Grade II* listed Hall is at the centre of this area and can be seen in distant views between the trees in the parkland. This grand ashlar faced house deserves its II* listing. It is an attractive focus of the Amington Hall Estate and the conservation area with its central bay breaking forward under a pediment, bowed porch entrance with Tuscan aedicule and paired 2-panel doors with flanking windows displaying the Repington family crest.

Grade II* listed Amington Hall

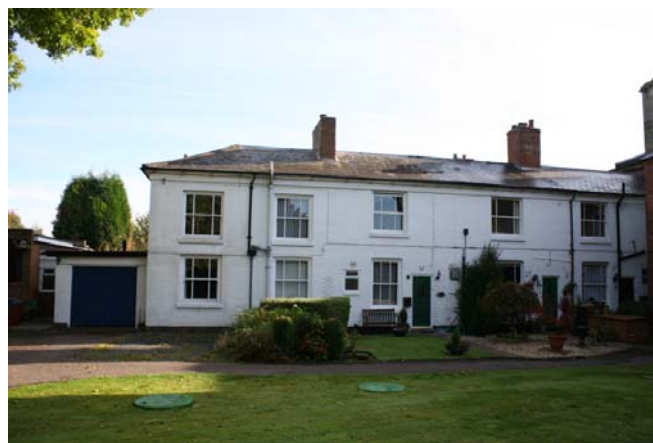
5.2.4 The brick-built rear wing, now converted into four houses, is an unusual accompaniment to the main house. Nevertheless the white painted houses with plain slate roof and three-over-three sashes are attractive and make their own contribution to the conservation area. A flat roofed garage to the north is, however, an unfortunate addition.

The brick-built wing

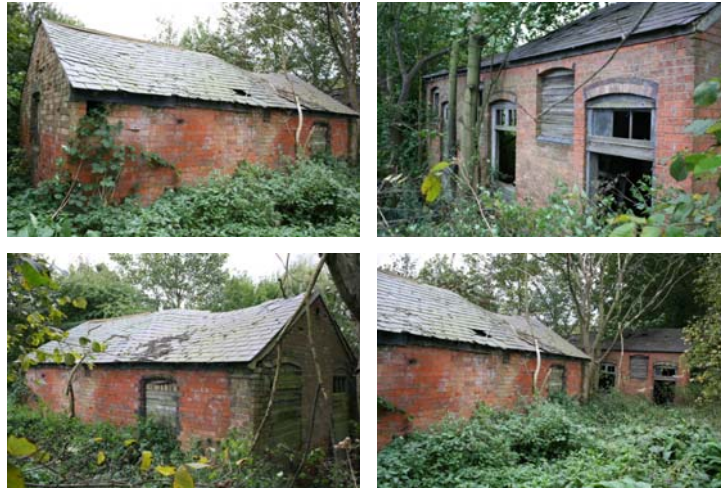
5.2.2 The rear grounds of the Hall are somewhat neglected. The red brick outbuildings to the north of the Hall are dilapidated, their walls undermined by trees and other vegetation. The large walled garden is now covered in brambles and weeds, and parts of its high brick boundary wall have collapsed or been removed.

- 5.2.5 The simple red brick outbuildings north of the Hall are in a precarious state. They have few architectural details of note but with their slate roofs and arched window and door openings they have some character. Their renovation would benefit the surrounding area.

The outbuildings in need of attention

5.2.9 The red brick outbuildings will collapse entirely if left to deteriorate further. While it may be uneconomical to restore these buildings, for which it may be difficult to identify a new use, their renovation should be considered. Likewise, the restoration and ongoing maintenance of the walled garden would have a clear positive impact on the setting of the listed building and on the character and appearance of the conservation area.

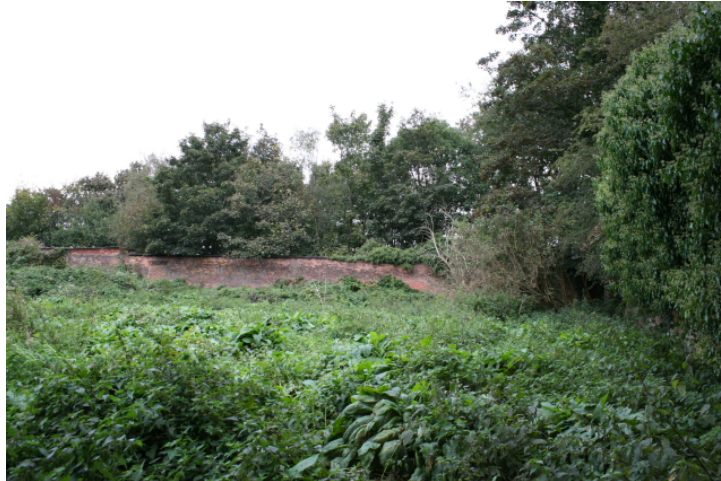
- 5.2.8 The grounds immediately surrounding the Hall are well maintained. However, the land to the rear incorporating the disused walled garden and many specimen trees (yews, variegated hollies etc.) is overgrown and the conservation area would benefit from its renovation and continued management.

The overgrown walled garden in need of renovation

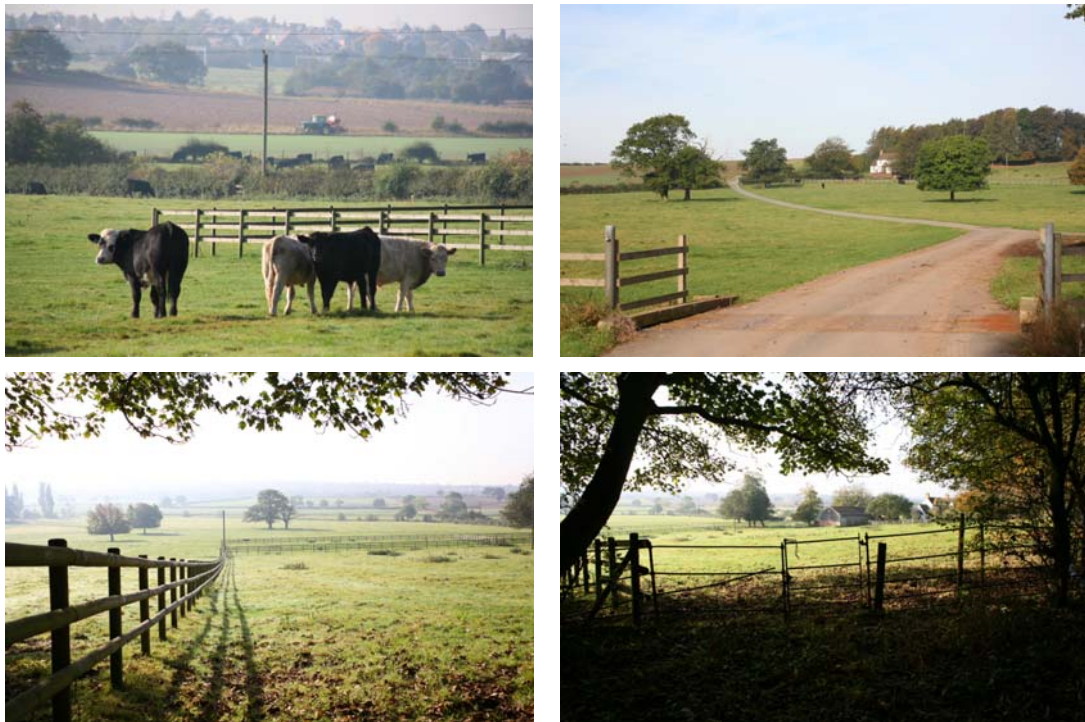
- 5.3.2 The estate's land is characterised by its gently sloping fields of red soil to the north and wide floodplain to the south. Trees are a prominent feature in the landscape with many small mixed woodland plantations. A number of old parkland trees survive and act as important visual and historical landmarks in the conservation area. There are distant views south, southeast and southwest to the surrounding settlements and countryside. Views to Tamworth take in St. Editha's Church and (unfortunately but inevitably) the town's large tower blocks and the Snowdome.

Views over the parkland

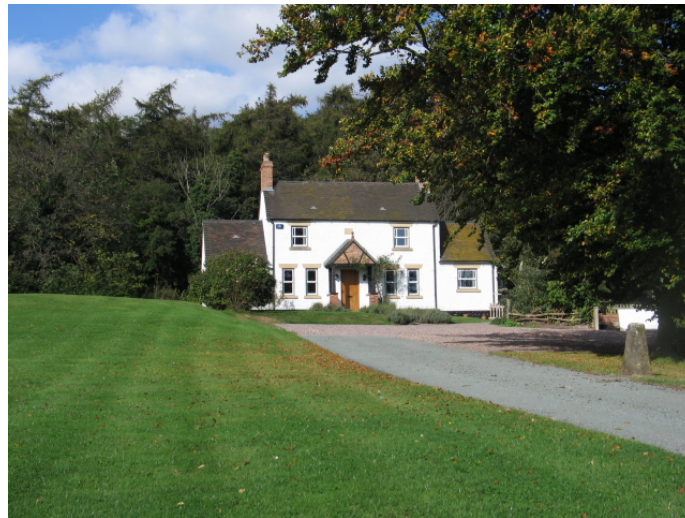
- 5.3.4 Ling Cottage, situated west of Amington Hall, stands in its own grounds within the estate. The cottage, presumably previously an estate worker's cottage, is a well proportioned building of understated design. It is an attractive addition to the estate and an important counter to the grand Hall and Old Hall farmhouse. The modern steel-framed agricultural building next to the cottage is softened by surrounding trees and shrubs and its painted green frontage.

Ling Cottage

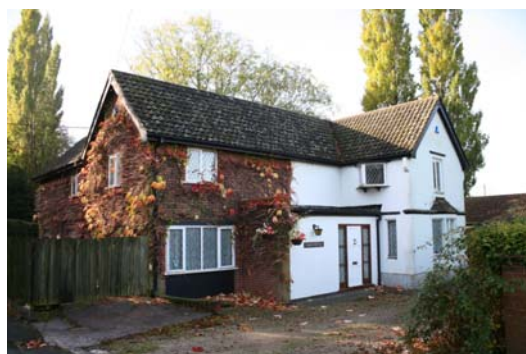
5.3.6 Amington Hall Lodge is also located on the side of Ashby Road, at the start of the entrance driveway down to the 19th-century Hall. Today's lodge is a modern building, replacing an earlier lodge on the same site, and is out of character with the original estate buildings, being more suburban in appearance than rural estate. As such, it is a poor roadside marker for the estate.

Amington Hall Lodge

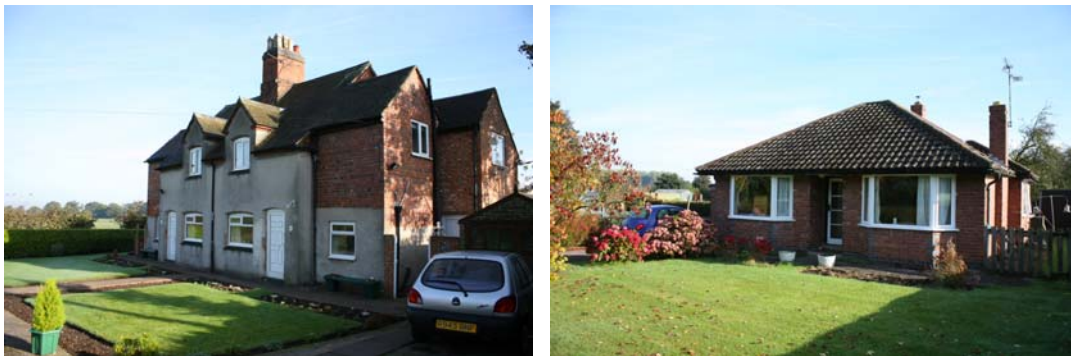
- 5.3.7 The late 19th-century Amington Hall Cottages are situated to the east of the Lodge. This pair of semi-detached, partly rendered, brick-built cottages have some interesting features such as the half dormers and massive central chimney stack but have suffered from unsympathetic replacement uPVC windows and doors. The cottages are served by large productive vegetable gardens complete with many glasshouses. To the south of the cottages is a 1950s red brick bungalow, one of a number of later, out-of-character additions to the estate.

Amington Hall Cottages and Bungalow

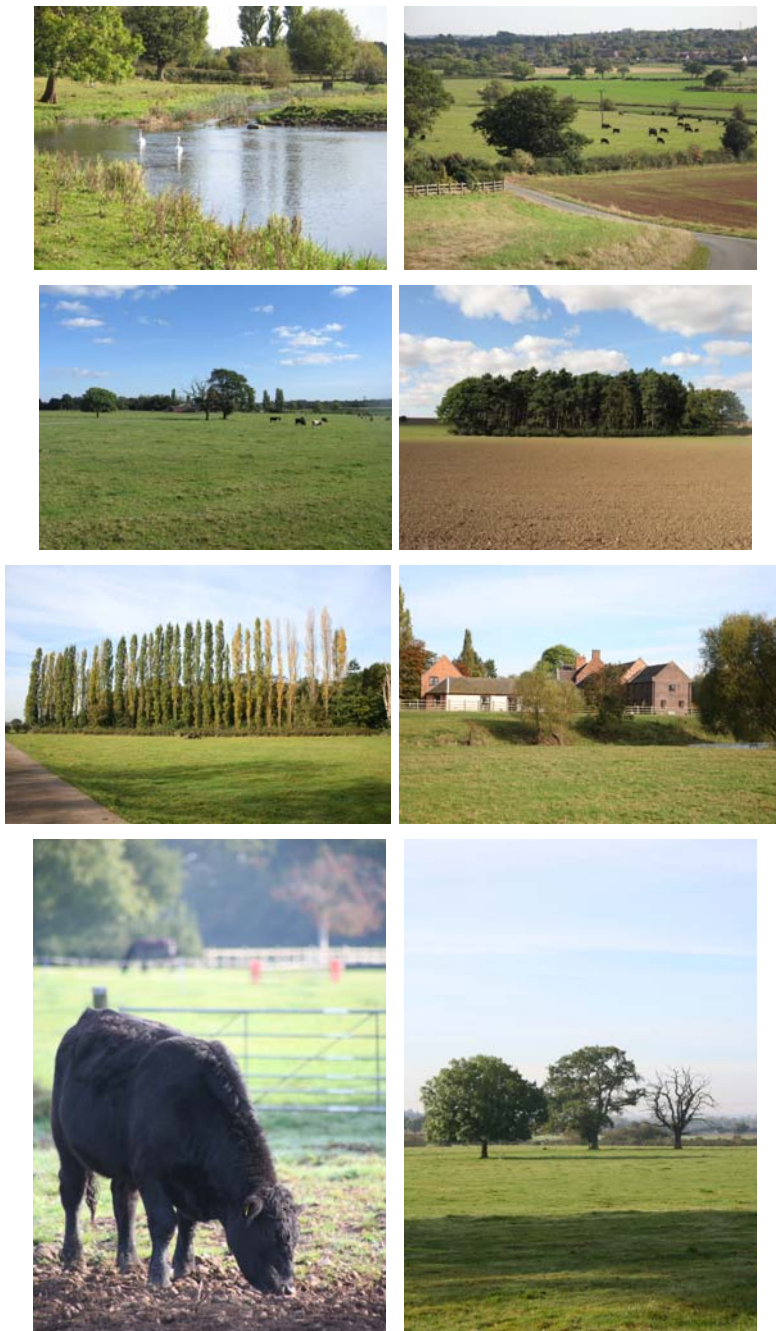
General views across the conservation area
